Guidelines for Detection, Analysis, and Treatment of Materials-Related Distress in Concrete Pavements Volume 3: Case Studies Using the Guidelines

PUBLICATION NO. FHWA-RD-01-165

AUGUST 2002

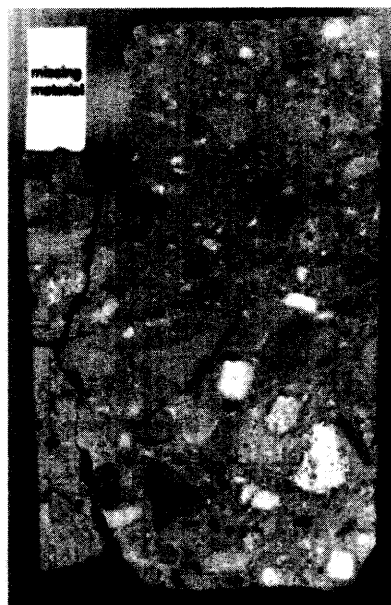
(a) Section 001, Core B

Based upon the field survey, distress was detected at joints and near slab corners. Photos of typical distresses are shown in figure 3-5. To look at concrete from more than one slab, Cores B and D were selected from Section 001 and Cores A, B, and C were selected from Section 002. All cores were cut to produce slabs for examination with stains.

Figure 3-5. Core specimens from SD-090-019.

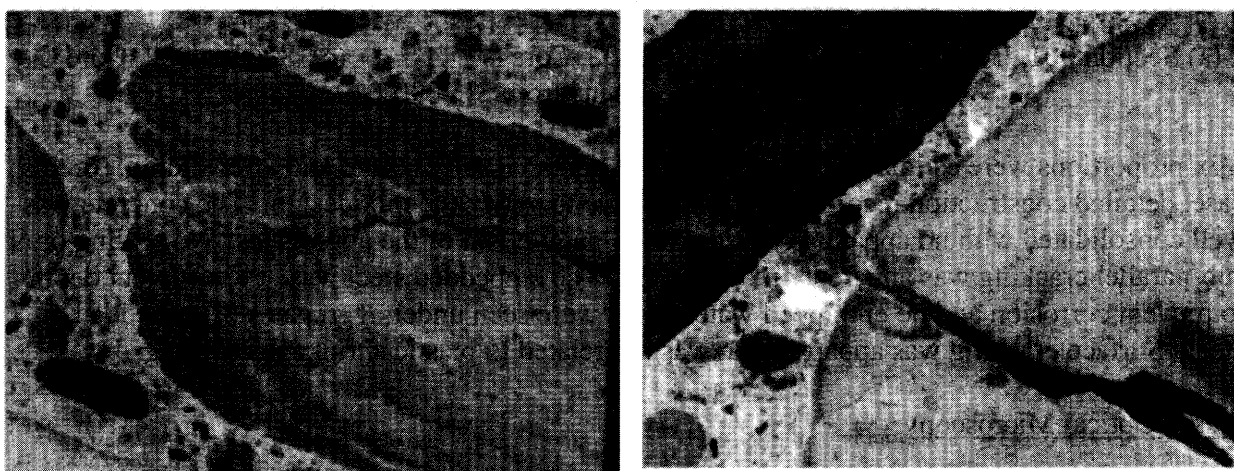
(a) Metamorphic aggregate

(b) Siltstone aggregate

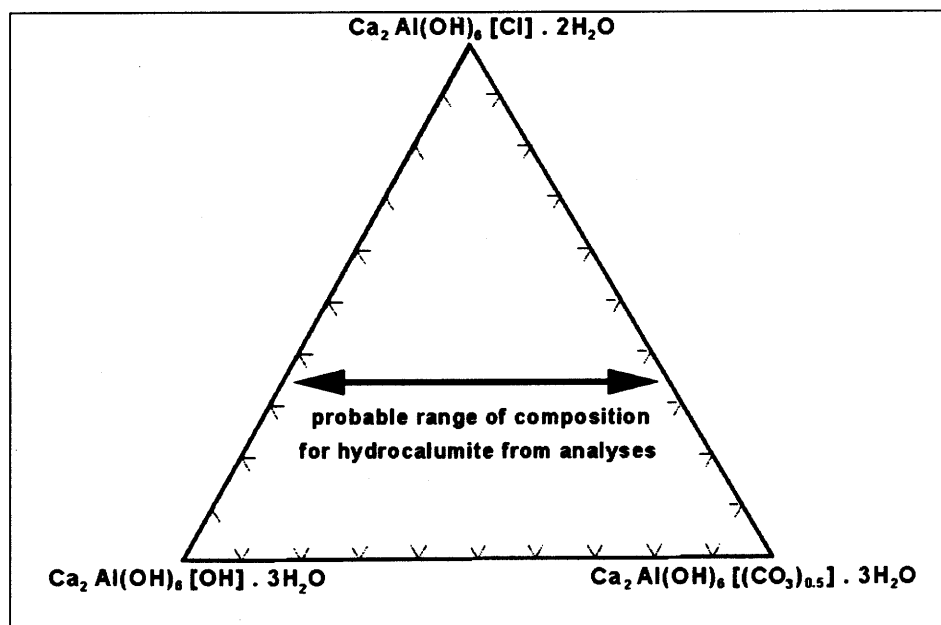
Figure 3-15. Ternary diagram showing the probable range of composition for the hydrocalumite deposits analyzed from SD-090-019.

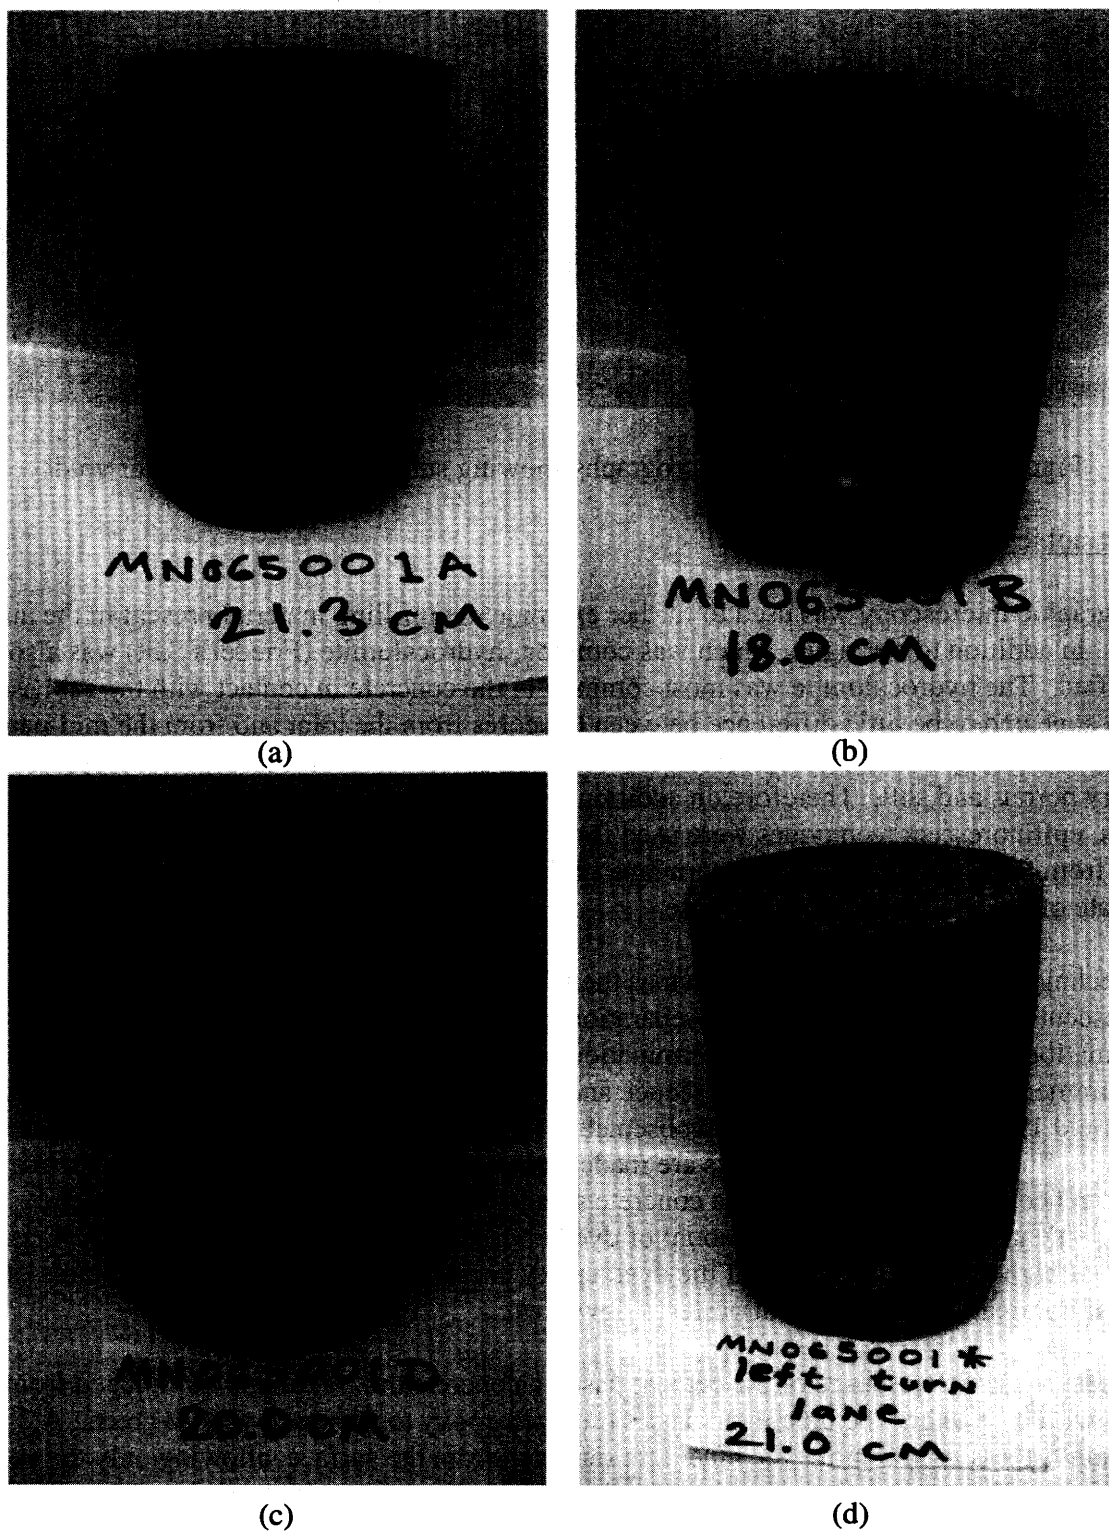
Based on the field survey and site inspection by researchers, the distress was determined to be concentrated at the transverse joints. In addition, the northbound turning lane was recognized as being in good condition even though it was approximately 40 years older than the badly distressed northbound Section 001. The guidelines for sampling were applied and four cores were retrieved from each section. Also, one mid-panel core (core D in standard pattern) was retrieved from the northbound (Section 001) left-turn lane. The cores selected for laboratory analysis were A from Section 002, cores B and D from Section 001, and core D from the left-turn lane. Pictures of these cores are shown in figure 3-22.

Figure 3-22. Cores evaluated for MN-065-064.

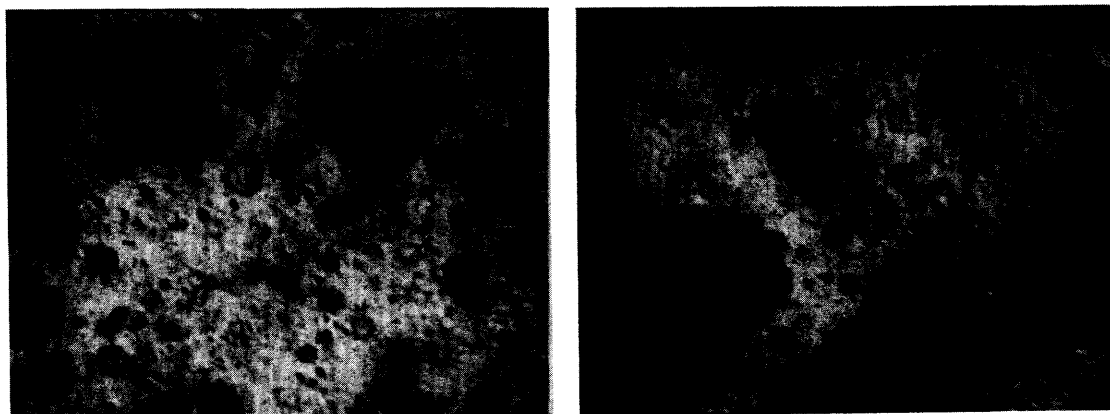
The rock type for the coarse aggregate was characterized as varying, but was dominantly mafic rock types typical of the Superior Lobe. The fine aggregate was the same, but with more quartz. No unusual alteration of the aggregate was observed. For this study, the most useful role for the stereo microscope was for observing stained specimens and determination of the hardened air content. The barium chloride/potassium permanganate stain described in Guideline II colors sulfate minerals a brilliant pink to purple hue as shown in figure 3-23.

Figure 3-23. Stereo optical micrographs showing sulfate minerals filling air voids.

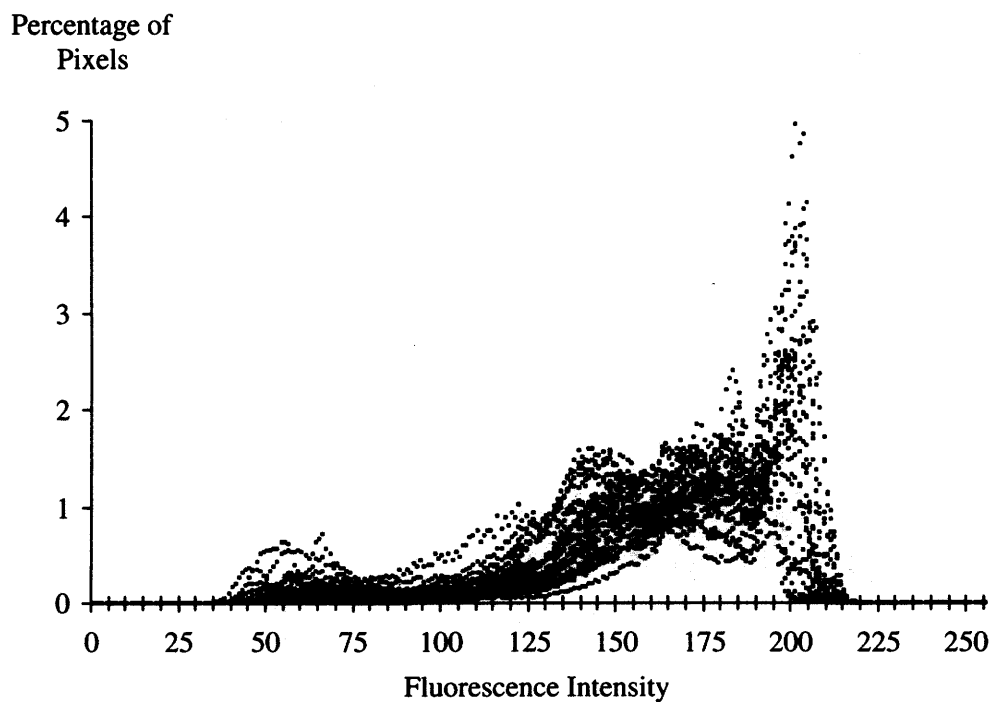
Figure 3-33. Histogram of fluorescence measurements from 1950 concrete from mid-panel of the left-turn lane of site MN-065-064-001.

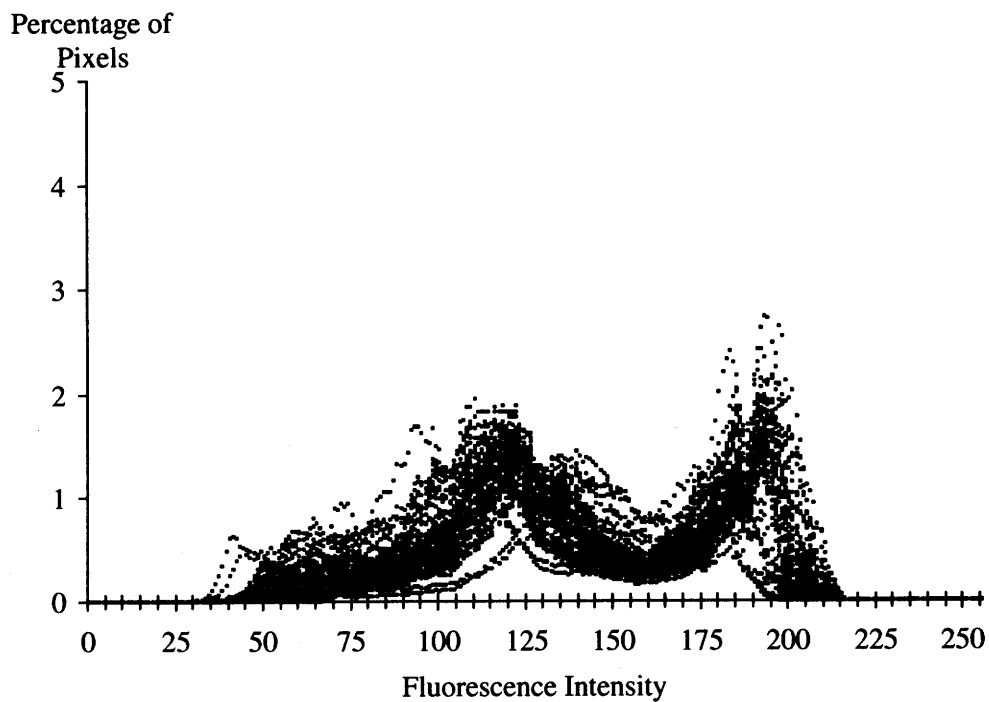
Figure 3-34. Histogram of fluorescence measurements from 1990 concrete from mid-panel of the traffic lane of site MN-065-064-001.

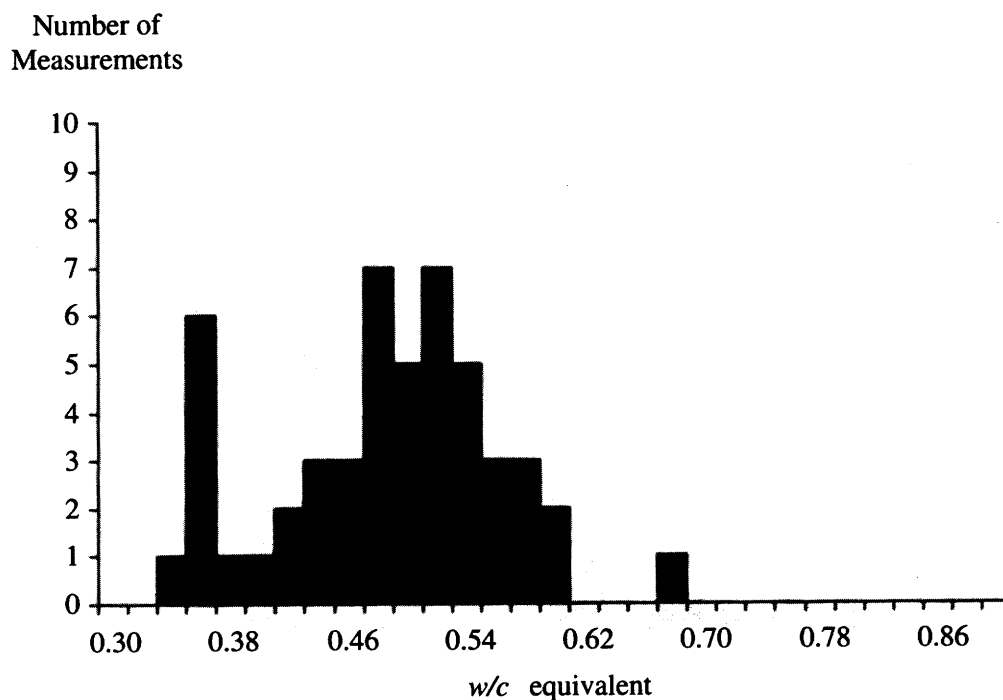
Figure 3-35. Distribution of the w/c values from the 1950 concrete from mid-panel of the left-turn lane of site MN-065-064-001.

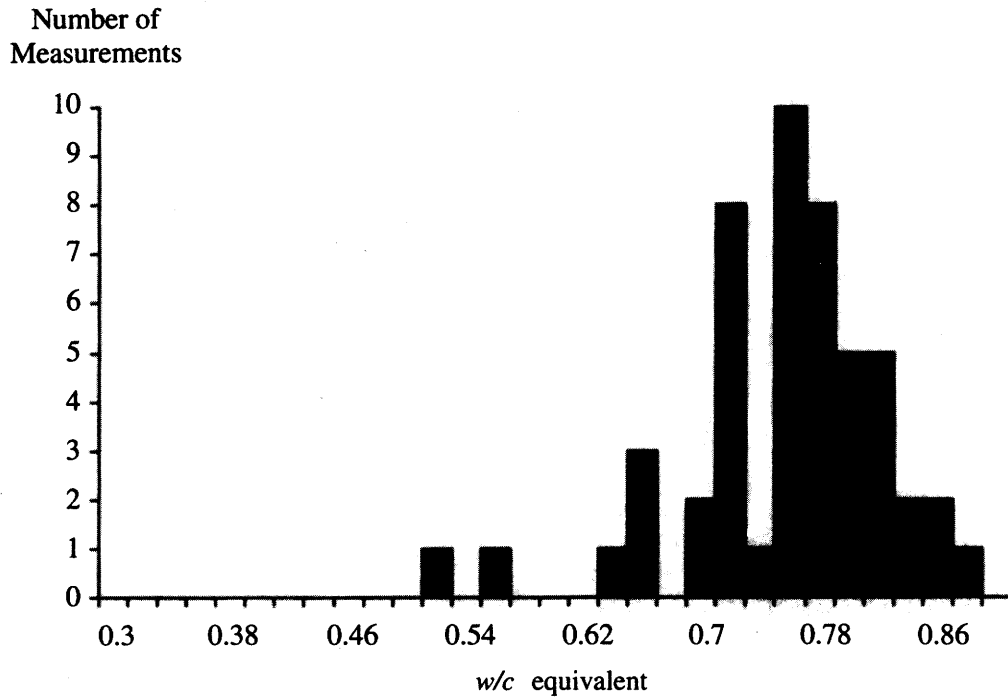
Figure 3-36. Distribution of the w/c values from the 1990 concrete from mid-panel of the traffic lane of site MN-065-064-001.

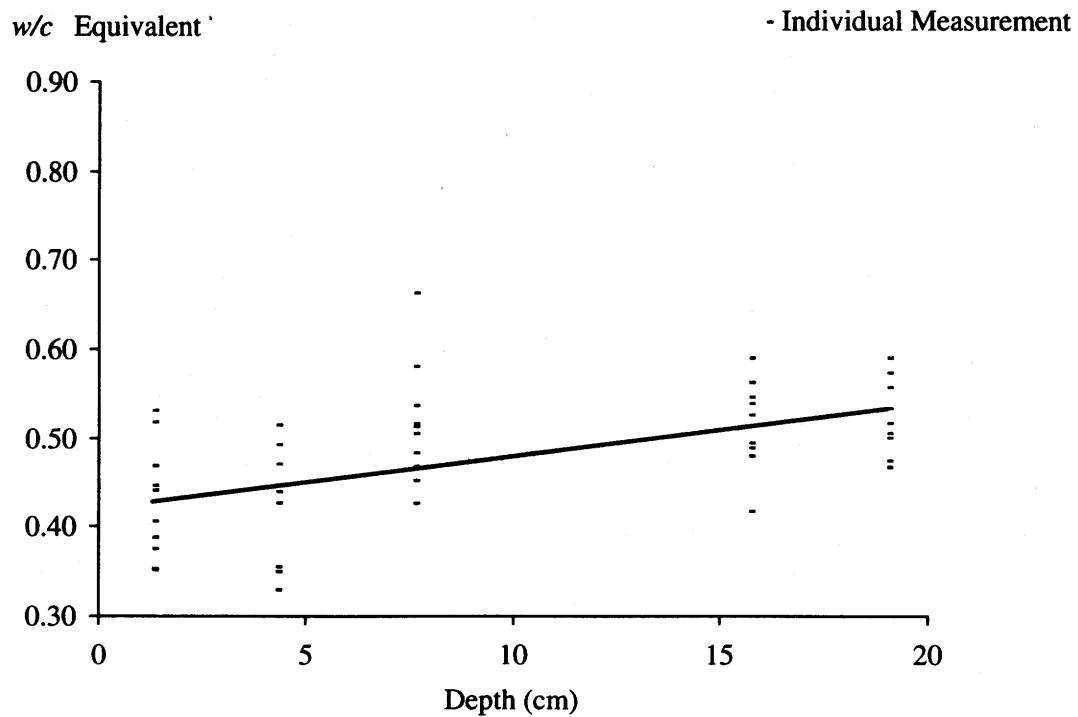
Figure 3-37. The w/c values versus depth from the 1950 concrete from mid-panel of the left-turn lane of site MN-065-064-001.

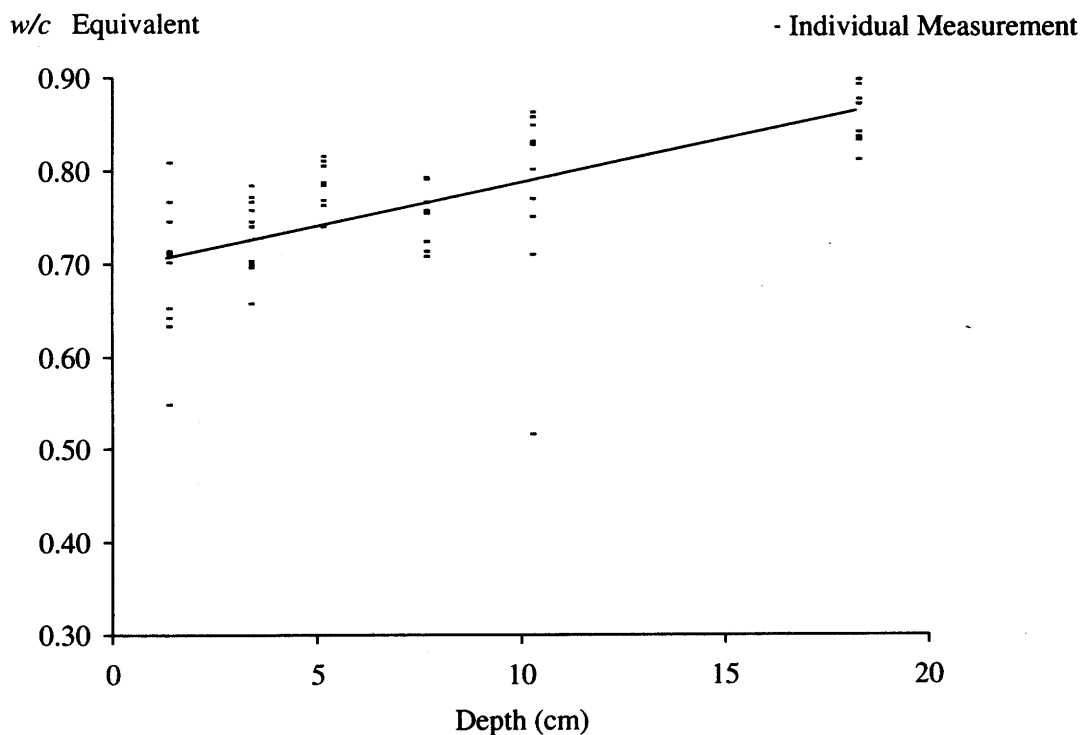
Figure 3-38. The w/c values versus depth from the 1990 concrete from mid-panel of the traffic lane of site MN-065-064-001.

Paste Freeze-Thaw – Clearly, there were two distinguishing features of this distressed concrete. The first was the softness and high effective *w/c* for this concrete. The porous paste was evident even in the mid panel when compared to the passing lane constructed with similar aggregates but approximately 40 years before the failed concrete. Of course, changes in cement characteristics and other factors may be contributors to the observed paste characteristics. However, it is unlikely that these factors would result in a difference of the magnitude seen in these pavement sections. It is most probable that a high *w/c* contributed to the observed distress. In addition, the original air system was marginal and once infilling occurred; the hardened air system became inadequate to protect the weakened paste.

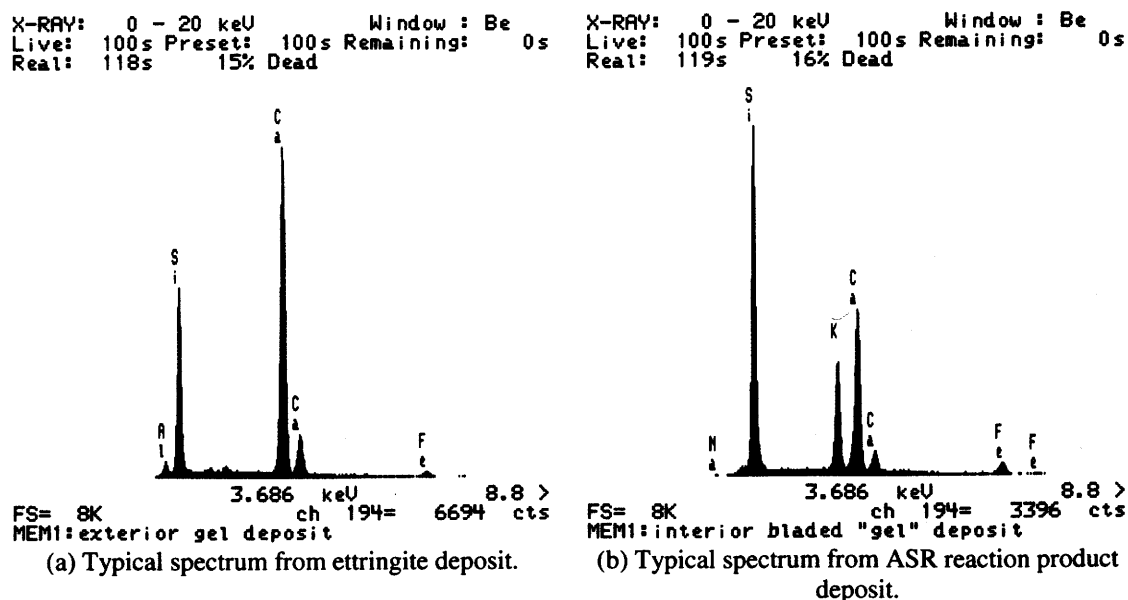
Figure 3-57. Typical spectra for ettringite and ASR reaction product.

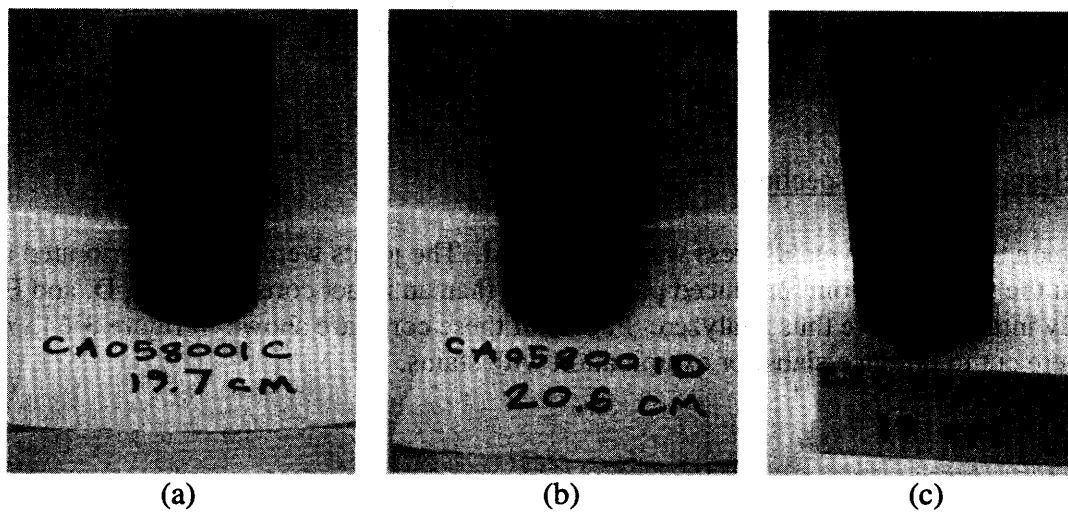
Based upon the field survey, distress was widespread. The joints were badly deteriorated and coring at the transverse joint produced pieces rather than an intact core. Cores C, D, and E were relatively intact and were thus analyzed. Photos of these cores are shown in figure 3-64. All cores were cut to produce slabs for examination with stains.

Figure 3-64. Photographs of core specimens analyzed from CA-058-141.

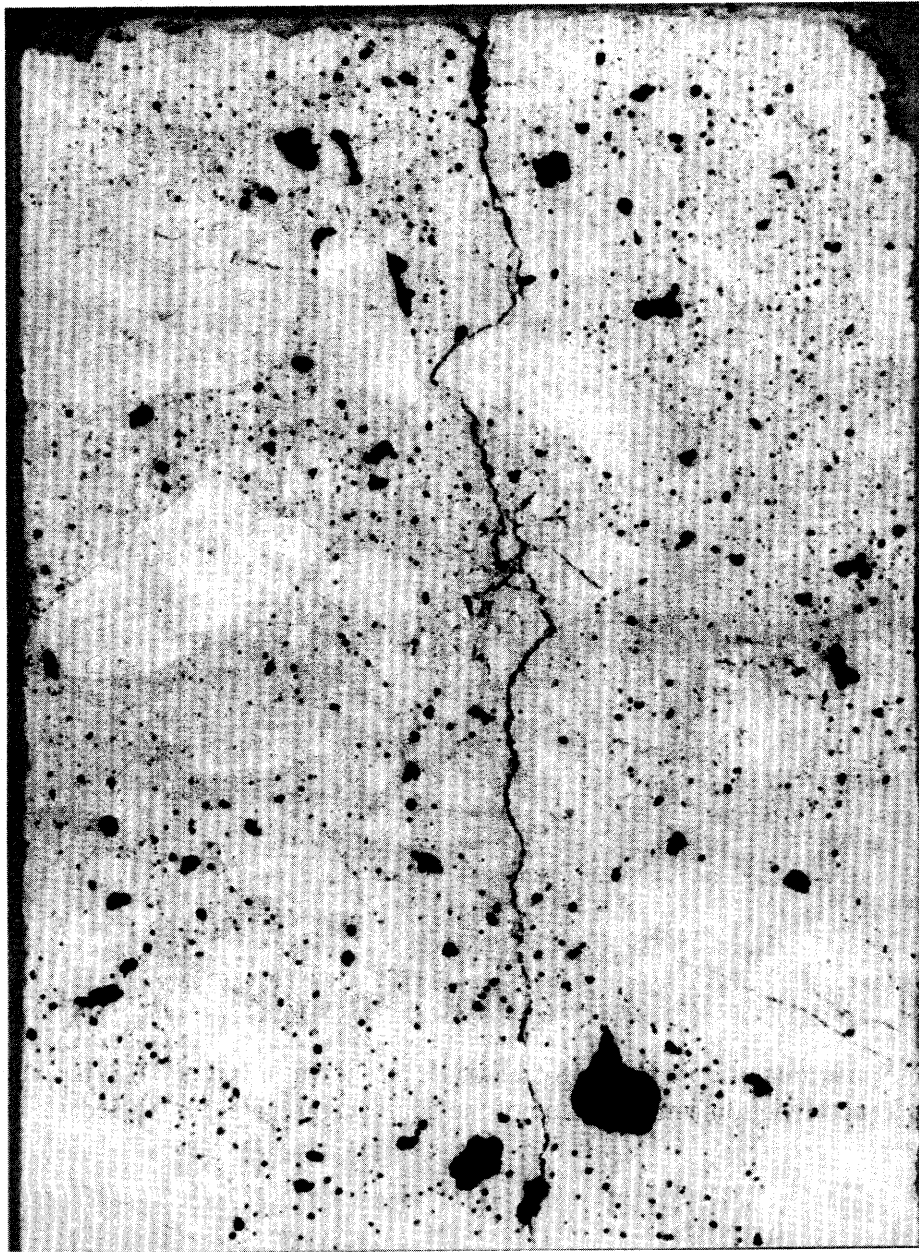
In figure 3-76, a crack is seen that runs the length of the image. It starts wide at the top and narrows as it goes deeper into the concrete, jogging around one large aggregate grain. That portion of the crack is typical of plastic shrinkage, wide and irregular at the pavement surface, where the paste was soft and cracked preferentially. The rest of the crack is more typical of drying shrinkage where much larger stresses are applied to the aggregates as the paste hardens with time. Stresses build to the point where the crack already started at the surface propagates through an aggregate and continues. Figure 3-77 is a normal scan of the same specimen. Some darkened rims are evident on the coarse aggregate, which is typical of ASR.

Figure 3-76. Inverse image of polished cross section of core CA-014-011-001E, through pavement, after painting the surface black and pressing white powder into the voids and cracks (magnified 1.5x).

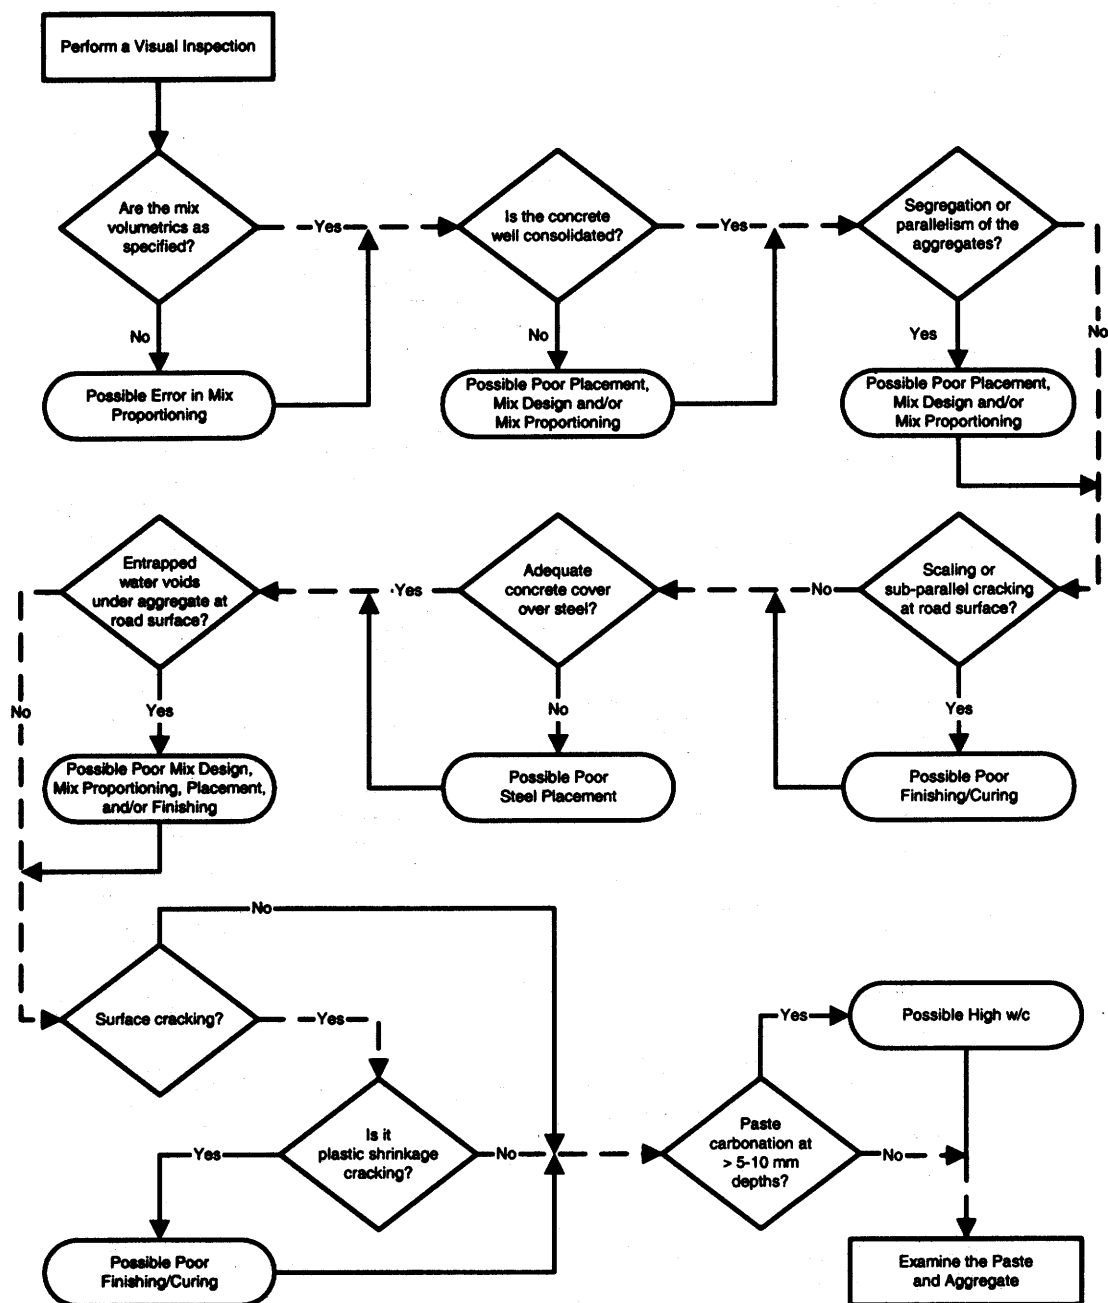
Figure 3-87. Flowchart for assessing general concrete properties based on visual examination as applied to IA-002-002.

Having performed the described laboratory analyses and applied the diagnostic flowcharts, as shown in figures 3-86 through 3-90, three possible MRDs were identified in IA-002-002, including paste freeze-thaw, ASR and sulfate attack with none being dominant or extensive. To

In summary, the exact nature of the observed distress is not known. The unusual air-void structure may be a contributor but the exact mechanism could not be discerned from this analysis. It is noted that the concrete had a very fine coarse aggregate grading, which may also be a contributing factor but, again, no evidence of a specific mechanism for the observed distress was seen related to this gradation. The guidelines do help rule out the obvious types of MRD but in the end, this is an example of a pavement that cannot be absolutely diagnosed using the developed guidelines.

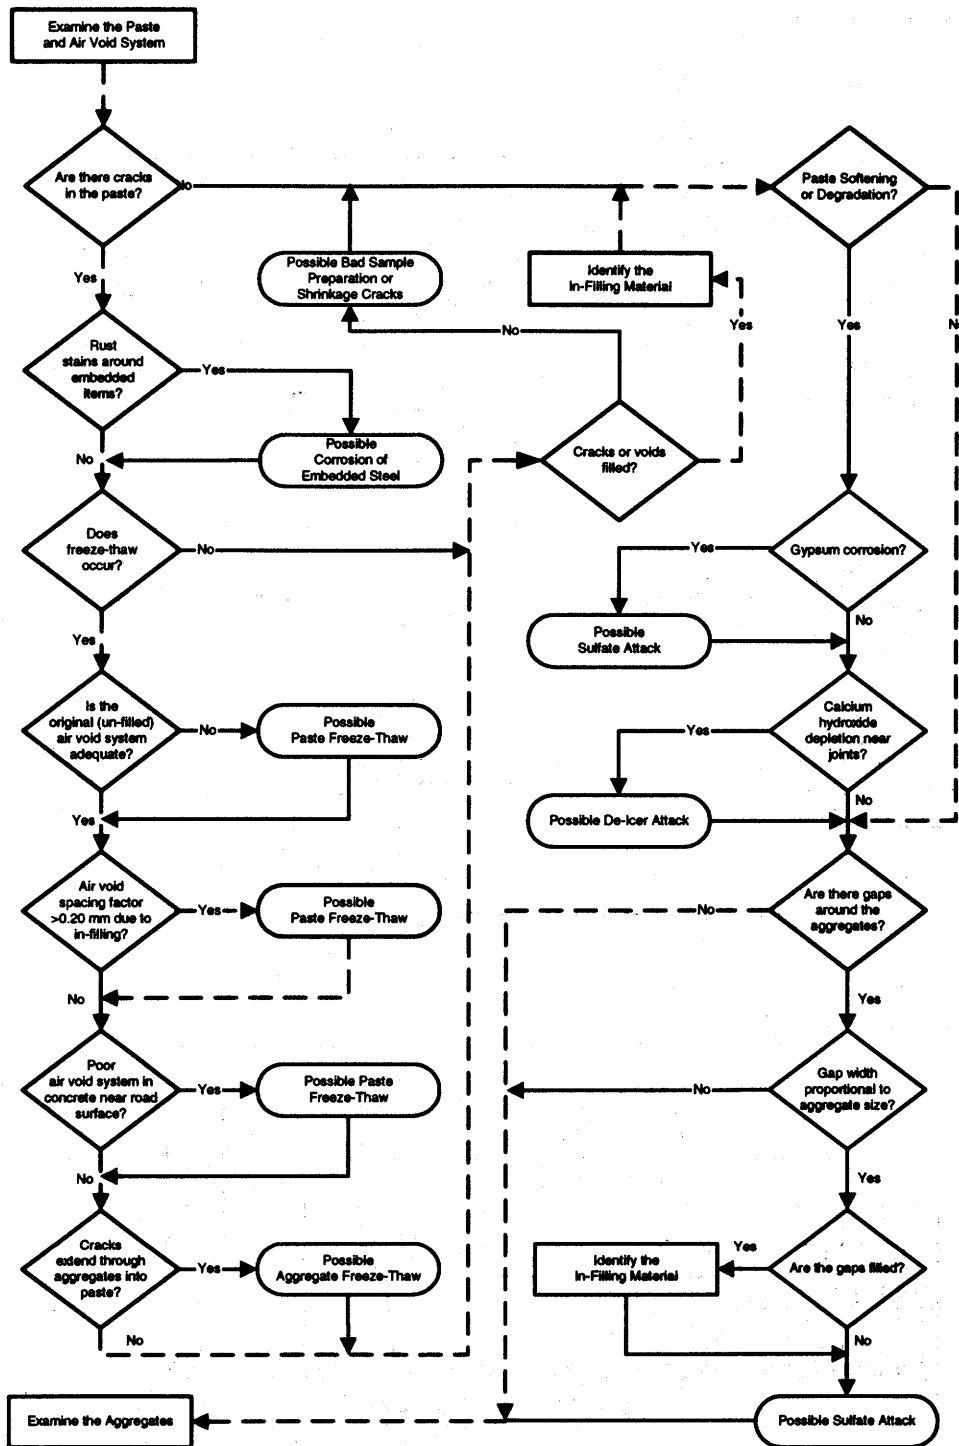
Figure 3-88. Flowchart for assessing the condition of the concrete paste as applied to IA-002-002.

Paste Freeze-Thaw – The only diagnostic feature of paste freeze-thaw present was the marginal air-void system in terms of the measured Powers spacing factor. This is considered to be a diagnostic feature of low significance given the fact that no other diagnostic feature of paste freeze-thaw was seen. As a result, paste freeze-thaw is not considered to be a major cause of the observed distress.

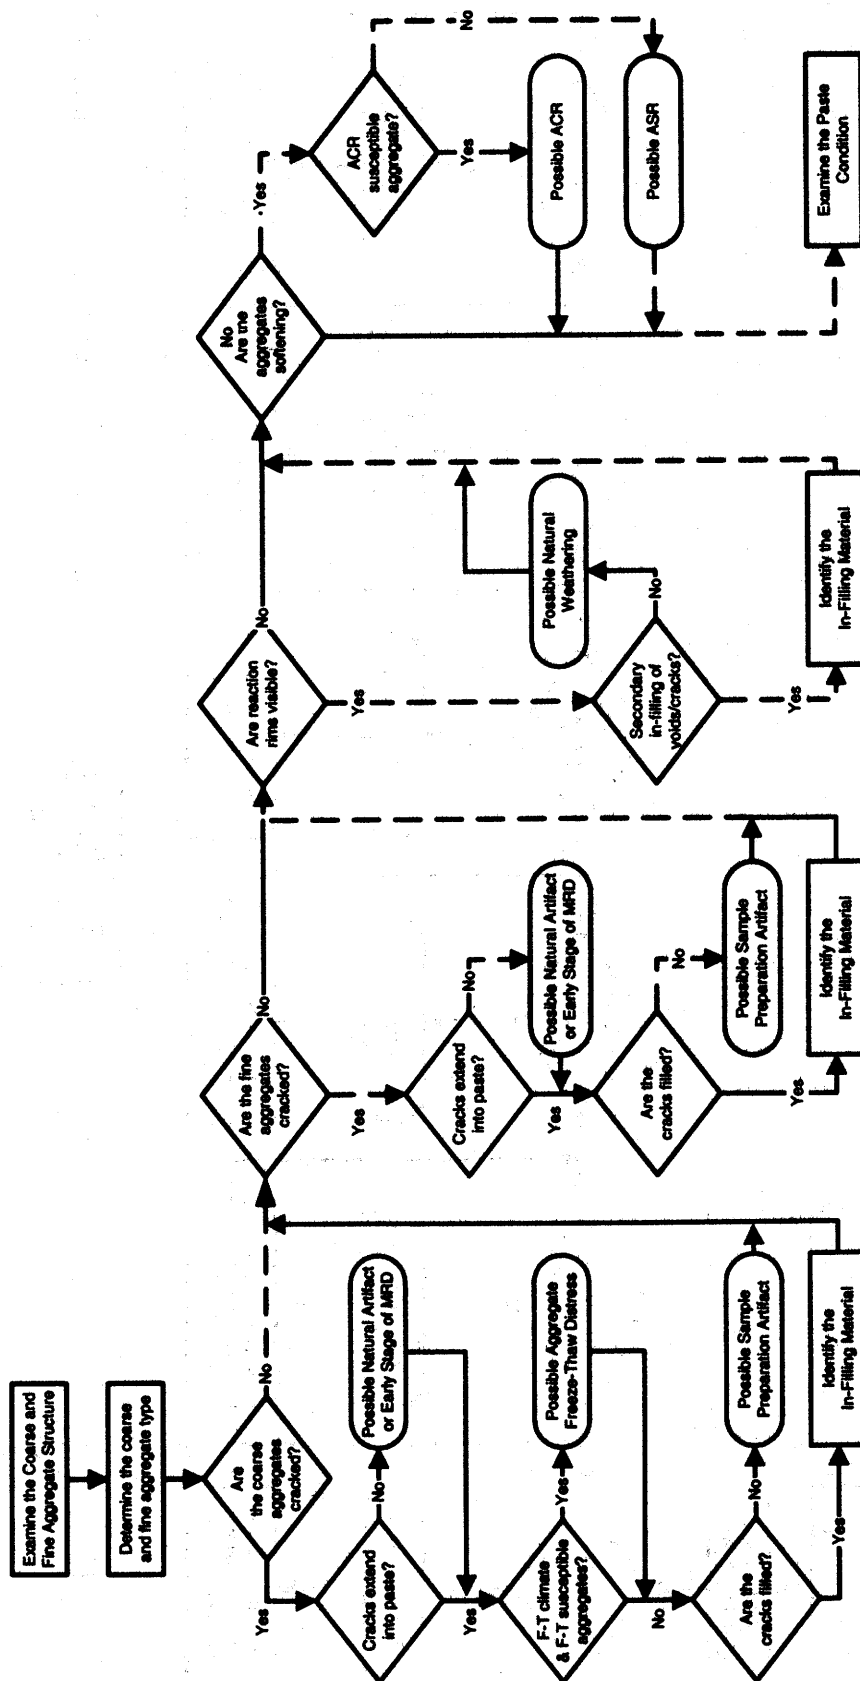
Figure 3-89. Flowchart for assessing the condition of the concrete aggregates as applied to IA-002-002.

ASR – The ASR occurring in this pavement was not extensive and did not seem to be related to any of the observed cracking. As a result, ASR is not considered to be a major cause of the observed MRD. This does not rule out ASR in its early stages as being present.

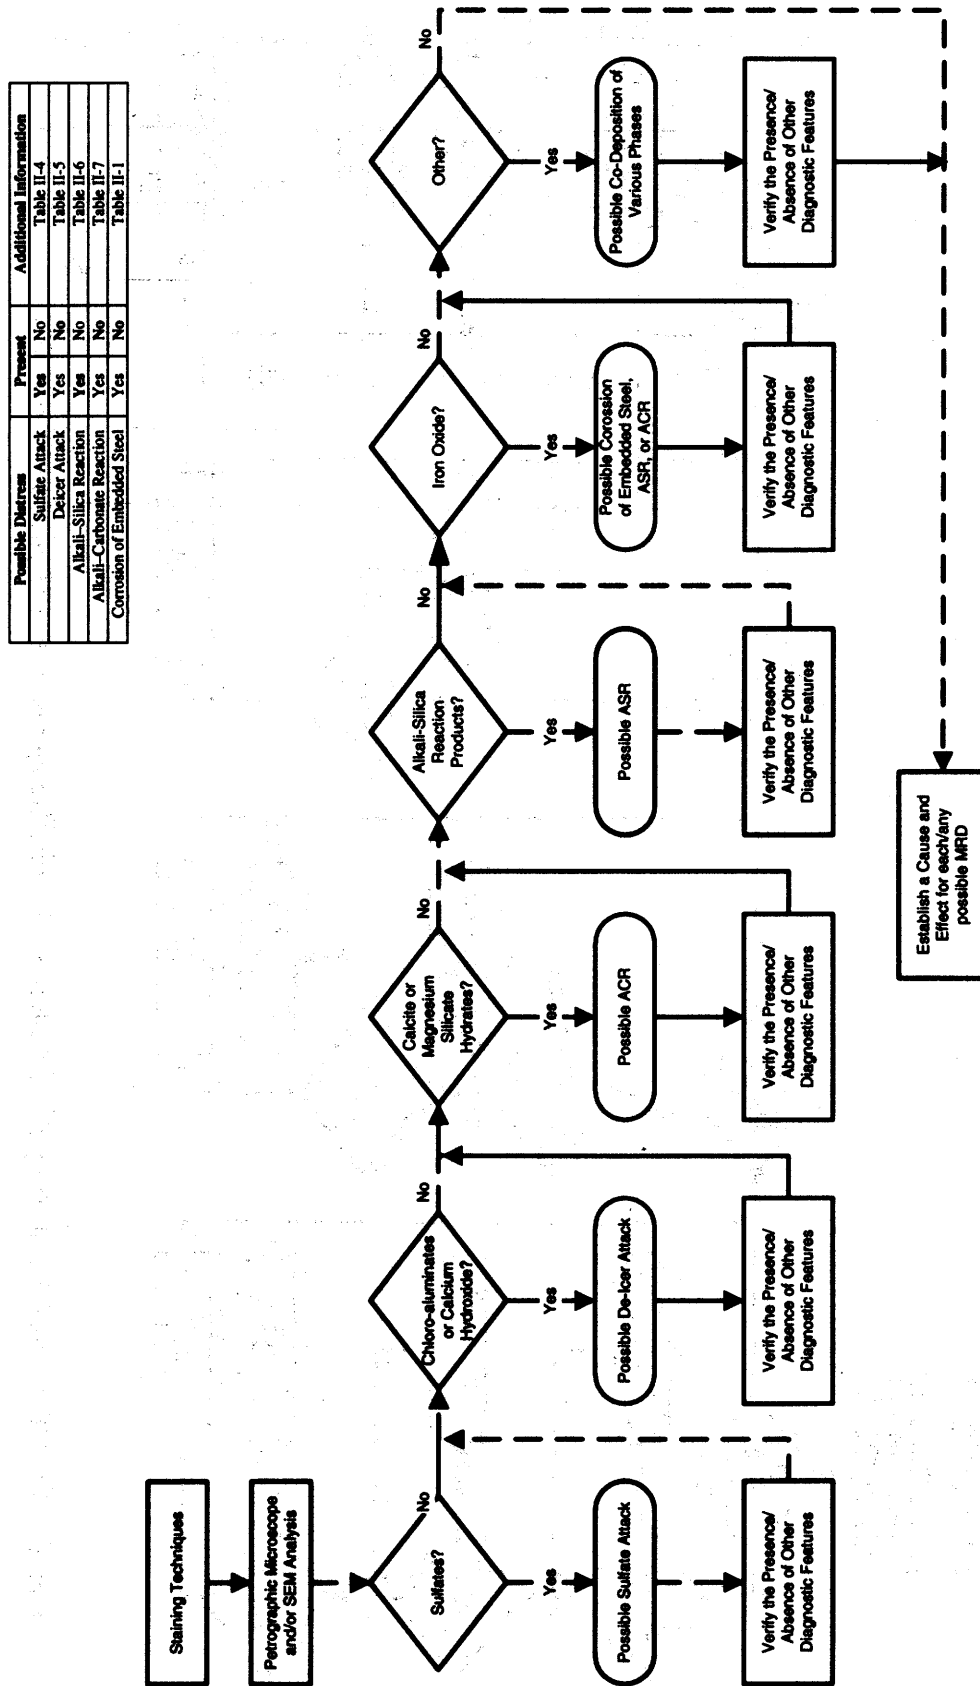
Figure 3-90. Flowchart for identifying infilling materials in cracks and voids as applied to IA-002-002.

Sulfate Attack – The only diagnostic feature of sulfate attack was ettringite infilling in entrained air voids. This was considered a low significance diagnostic feature for a variety of reasons. First, ettringite deposits by themselves are not diagnostic of sulfate attack. Second, the amount of infilling was limited, not extensive. Finally, no other diagnostic feature of sulfate attack was observed. Therefore, sulfate attack is ruled out as a major cause of the observed distress.
